Boroscopy: A Technique to Identify the Cause of Pathological Manifestations in Sewage Pipes in Buildings

Abstract-This article is based on a pathological manifestation in the obstruction of the downpipe pipe of the sewage network, with materials from construction debris arising from the time of the building's construction, with the objective of studying the use of a non-destructive method to of boroscopy, this sensory perception diagnostic technique that uses a flexible probe with a mini boroscopy camera with the aid of a computer to visualize the interior of the pipe, having an immediate solution to correct and remedy the irregularities pointed out, thus avoiding the evolution of problems already existing and worsening of the situation, due to the facts that caused material and psychological damage due to these pathological manifestations.

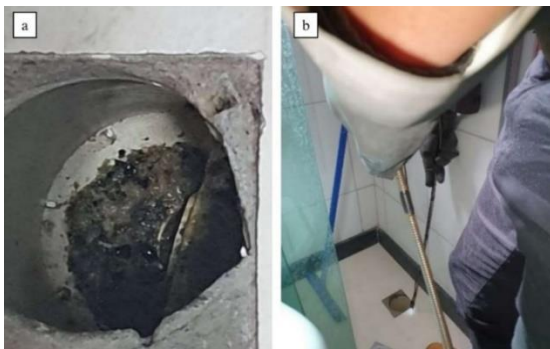
In the on-site inspection, initiated by the removal of the drains, the incidence of sanitary sewage in the water closure of the drain siphon box can be verified, a fact that should not occur, which generates great discomfort such as a bad smell in the sanitary environment [12], as shown in Fig. 3.

Figure 3. a) Siphoned drain with presence of waste water, b) Attempt to inspect the siphoned box drain

Due to the siphon in the box, it was not possible to introduce the equipment from that point on. Therefore, the removal of the toilet was provided to access the primary piping, also verifying the existence of residual water under the toilet bowl from some recent sewage reflux, which should not occur in accordance with [13], as shown in Fig. 4.

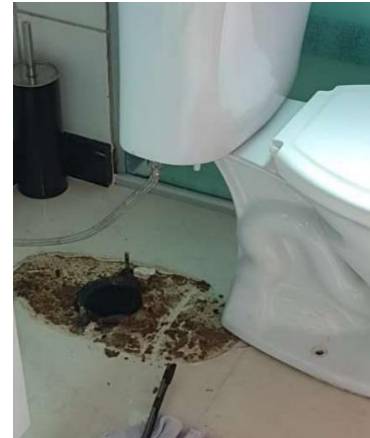
Figure 4. Removal of the toilet bowl and evidence of effluent backflow

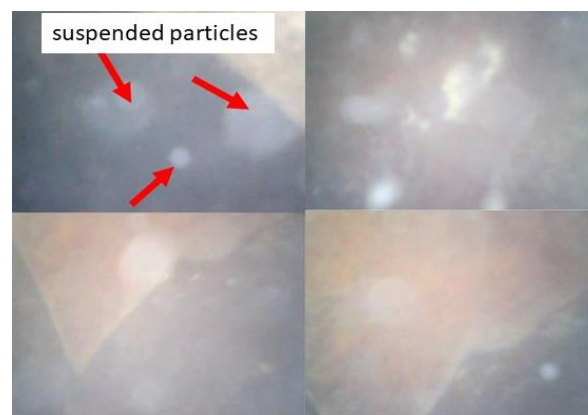
When introducing the probe with the camera, it was observed that the section between the toilet and the TQ-2 Ø drop tube (primary branch) was completely full (full section) as seen in Fig. 5, something that should not happen, as the normal would be only part of the pipe section should remain with liquids. Therefore, the introduction of the camera was done with care to avoid the suspension of particles preventing the filming.

When entering with the camera in the sub-collector of the primary branch, it was possible to identify the connection of the branch with the drop tube, as seen also by the length of the probe already introduced in the pipe, and when making the curve with the equipment, you can see an orange colored object embedded in a hard material with whitish debris.

Figure 5. There is hard orange colored material with whitish debris. Primary branch with full section of effluent.

Building sewage pipes are subject to obstructions, the consequences of which compromise the health, comfort and well-being of the people who inhabit the building. In view of the photographic evidence, footage obtained in the endoscopic inspection, and on-site verification, we can say that the problem presented in the property was caused by the obstruction of the downpipe pipe of the sewage network, with materials from construction debris resulting from the time of construction of the building, more specifically in Block 2, probably due to execution errors, as in other units of the condominium, this situation does not occur. Moisture from infiltration accelerates the process of deterioration of structures by inducing concrete degradation, corrosion of reinforcement, anomalies in paints and other coatings, thus compromising the durability of the building. The main function of a watertight and waterproof system is to provide the habitability and functionality of the building, as well as the health, safety and well-being of users, in addition to the preservation of real estate assets formed by the built heritage. Therefore, based on good construction practices in engineering and civil construction in current and applicable standards, in the terms transcribed from the Brazilian Civil Code and Consumer Defense Code [14], in view of the technical constructive non-conformities, and the lack of performance of the inspected systems, making it if necessary, immediate intervention is required to correct and remedy the identified irregularities, thus avoiding the evolution of existing problems and aggravation of the situation, due to the facts that caused material and psychological damage due to these pathological manifestations.
