Numerical Study of Slope Stability in an Anchored Wall in Belo Horizonte, Brazil

Abstract- The present work presents a study on an emergency containment work carried out on one of the main avenues of the capital of Minas Gerais in the year 2018. This structure comprises a curtain anchored by rods installed on a containment of the same nature that was instated as a function of corrosion in the head of the rods due to saturation of the slope. The stability of the problem was analyzed by means of the rigorous equilibrium-limit method (Morgenstern-Price), with the help of GeoStudio 2019 software, SLOPE/W module. Through modeling using finite elements in the Sigma module of GeoStudio, A 2D strain study was carried out for the following "In Situ" scenarios (before reinforcement rods and after the application of the new reinforcement lines). Additionally, the Elastoplastic model was considered representative of the Geotechnical massif. In general, the study returned a significant increase in the safety factor of the slope conferred by the anchored wall and acceptable horizontal displacements, of the order of 1, 5cm.

Keywords- *Anchored Wall, Slope Stability, Numerical Analyses with FEM*

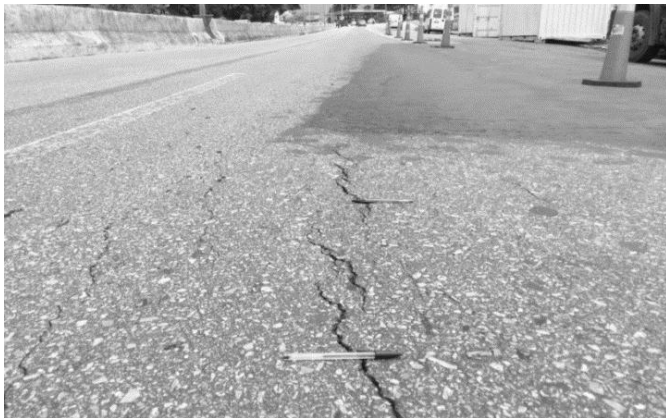
In March 2018, the Civil Defense of Belo Horizonte identified the movement of this anchored Wall (about 10cm) of thrown wall installed in the 70's in this part the city. The anchored wall was made by GEOTOP and composed by 12 ties (8mm thickness), 2.5m spacing (Fig.2).

Figure 2. Cracks detail on the crest of the slope. (Image courtesy of Thiago Bomjardim Porto)

This movement is accompanied by cracks in the asphalt and repression of the slope crest.

The dignity of the instability of this slope was associated with its saturation promoted by water leakage from the Morro do Redondo Treatment Station (COPASA) and poor surface and underground drainage systems. Due to this saturation, there was corrosion of the prestressed reinforced anchor in the bulb and, consequently loss of performance (loss of prestressing by steel relaxation and loss in the load capacity of the tie-rod.)

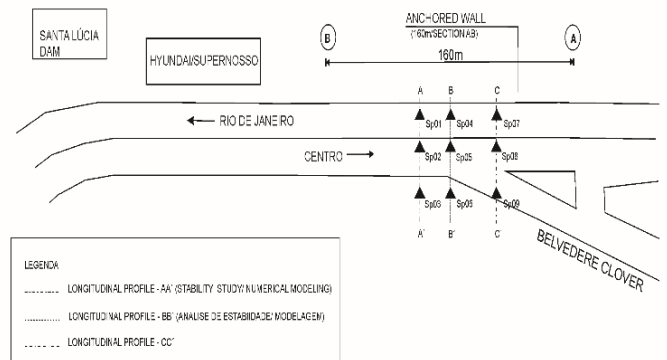
The main measures adopted to pre-manage the anchored wall's risk of collapse involved: 1) provisional drainage of the geotechnical massif with the installation of sub-horizontal drains to reduce lateral Earth Force into geotechnical massif; 2) Implementation of techniques for investigation of leakage in COPASA water pipes and consequent repair of them; 3) Implementation of topographic monitoring systems of the retaining wall (total station and geotechnical radar); 4) emergency provisional reinforcement of one panel of the anchored wall with implantation of 3 metal beams anchored in neighboring panels by tie- rods with $\phi 47\text{mm}$ with a work load of 833.6KN . After provisional reinforcement of the panel, 8 SPT drillings were performed near the wall and the open cracks in the asphalt were closed (Fig.3).

Figure 3. Sketched of anchored wall and geotechnical sections.

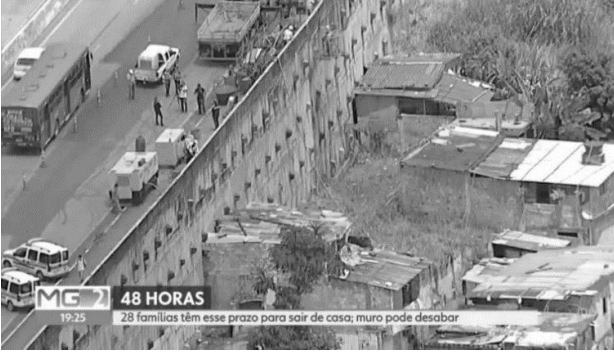
Figure 4. Houses in the immediate vicinity of the wired wall.

Concomitantly with the actions taken above, there was also the removal of families that lived below the wall (Fig.4).

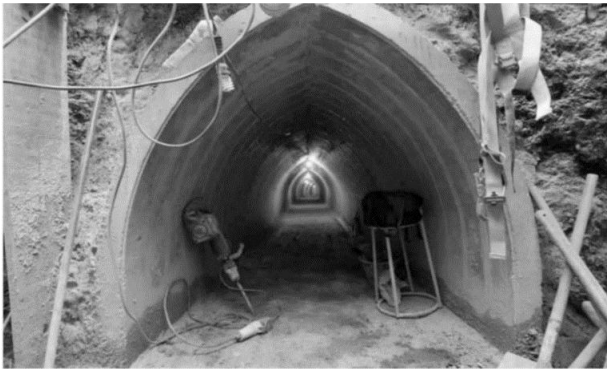
In order to ensure the durability and efficiency of the definitive restraint wall, were executed: 1) Permanent drainage system consisting of sub-horizontal drains and weep holes; 2) A conventional BSTC $\phi 1, 5\text{m}$ with 63m extension and a 140m long bullet tunnel located upstream of the anchored wall for rainwater capitation(Fig.5); 3) Flexural wall for slope containment at the end of the anchored wall; 4) Filling an existing drainage system under the mass that was damaged with the risk of internal rupture (BDTC $\phi 1, 0\text{m}$) by means of compacting concrete injection;

Figure 5. Bullet tunnel(140m in length, 1,6m tall e 1,5m de wide)was intended for rainwater collection. (Estado de Minas, August 2018)

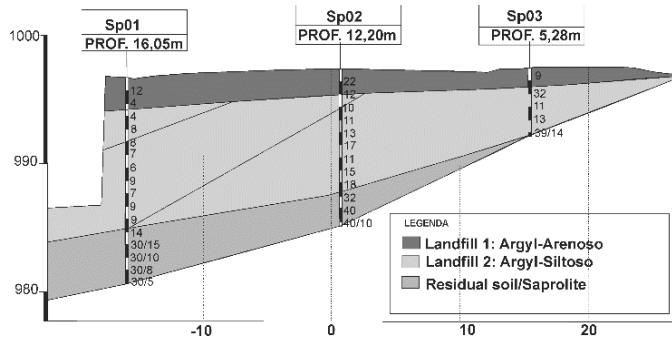
Penetration Test (SPT) executed in the study area (Fig.7, Fig.8). Thus, from the top to the base: 1) 0 to 0, 45m of asphalt cover or concrete floor; 2) 1, 25m to 6m of landfill composed of argyl-sandy material with rust canga shafts, brown, soft to hard; 3) 4 to 14m of Silto-Argyl-Sandy landfill (fine sand) to clay-silt with boulders, hard tough, pinkish color; 4) 0 to 1, 15m of residual soil of filito, clayey silt, with little sand, hard rough; 5) Saprolito de Filito, very altered, pink gray, hard.

Figure 7. Geological-geotechnical Section AA' (est 6 + 7,59).

Based on geological-geotechnical profiles, the values of the geotechnical parameters consolidated for the materials present in the study were presented, namely: specific weight, cohesion, friction angle and modulus of elasticity (table I).

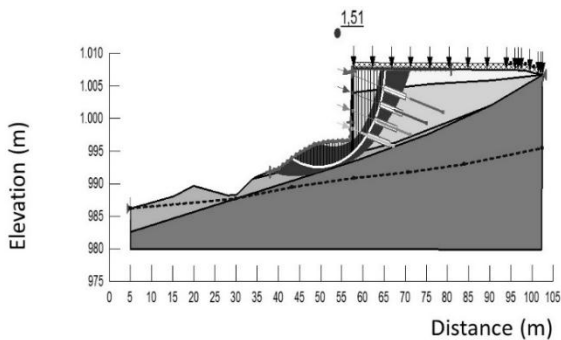
Through the result of the stability analysis, it is verified that the addition of the reinforcement rods gives a significant improvement in the safety performance to the structure and to the mechanism of external instability of the massif. Such verification is validity by means of the FS value found, which was 1.1 and, after reinforcement, became 1.51 according to the minimum factor recommended by [5] (Fig.9; Fig.10).

Figure 10. Stability analysis, with anchored wall- Section AA'.

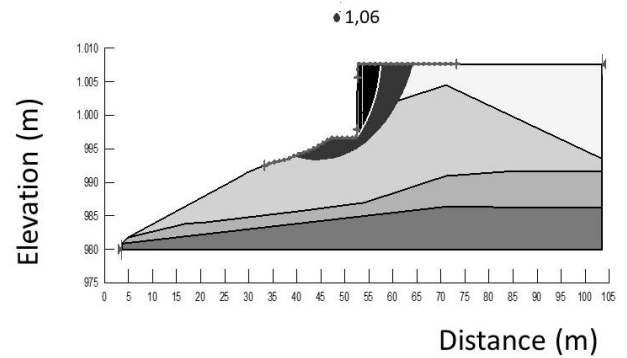
As verified in the AA' section, once more the result of the stability analysis confirms the conference of improvement in safety performance to the structure as the external instability of the massif, the FS value found was 1.06 and, after reinforcement, passed to 1.46, meeting the minimum factor recommended by [5]. When the result is approximate to 1 decimal place, as presented in the slope Stability Standard [21], Fig.11, Fig.12.

Figure 11. Stability analysis, without anchored wall- Section BB

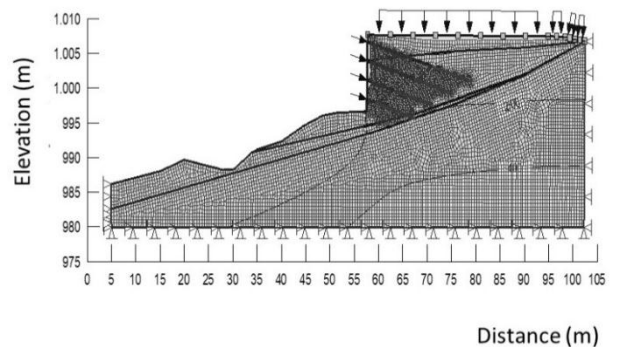
Figure 13. Deformed finite elements mesh containing the representation of the magnified displacements 100 times- Section AA'.

Through the graph of Fig.13, Fig.14, the horizontal displacement predicted on the face of the curtain, after the installation of the rods, is of 1.5 cm – a reasonable value for a structure of this size. The graph of Fig. 15 shows the vertical displacement of the pathway, with an approximate 2.2 cm of movement.

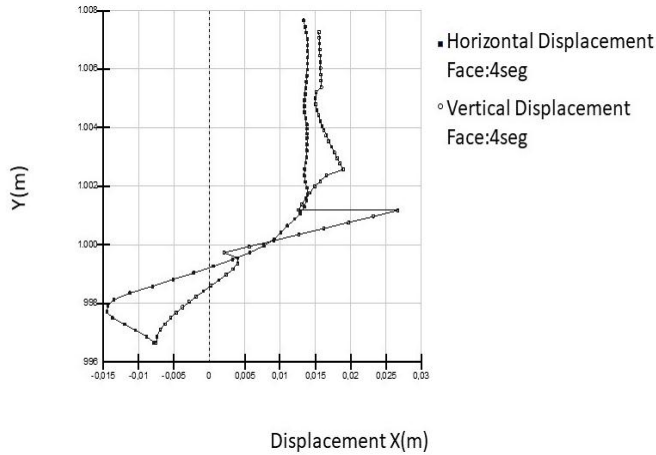
Figure 14. Comparative graph between horizontal displacements on the anchored wall and 1m away from the face, Section AA´.

The use of numerical tools to predict horizontal displacement with reinforced slope returned values of the order of 1,5cm. These values are considered reasonable and inferior to the horizontal displacement (of the Order of 10cm) associated with the formation of cracks on the crest of the slope of Avenida Nossa Senhora do Carmo. This shows the efficiency of the containment dimensioned at 2018.

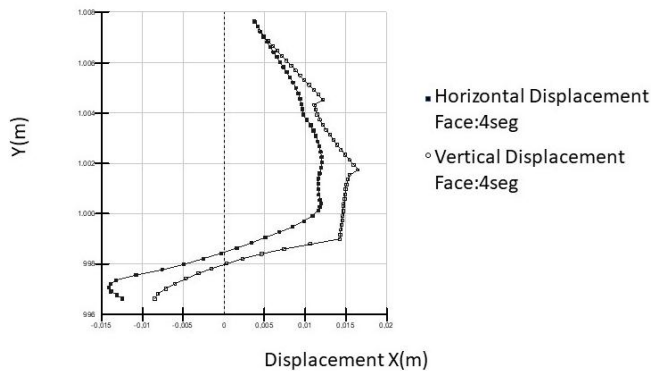
The result presented in section AA´, (Fig.17 e Fig.18), shows that the horizontal displacement predicted on the face of the anchored wall, after the installation of the rods, is of 1.5 cm, reasonable value for a structure of this size. The graph of Fig. 19 shows the vertical displacement of the pathway, with an approximate 2.7 cm of movement.

Figure 18. Comparative graph between horizontal displacements on the anchored wall and 1m away from the face, Section BB.
